Technical Bulletin

**Subject: Sill Panel Undercoating or Body Damage Due To
Contact With Hoist Lift Arms or Floor Jacks**

Number: 00-01

Model(s): TT Coupe

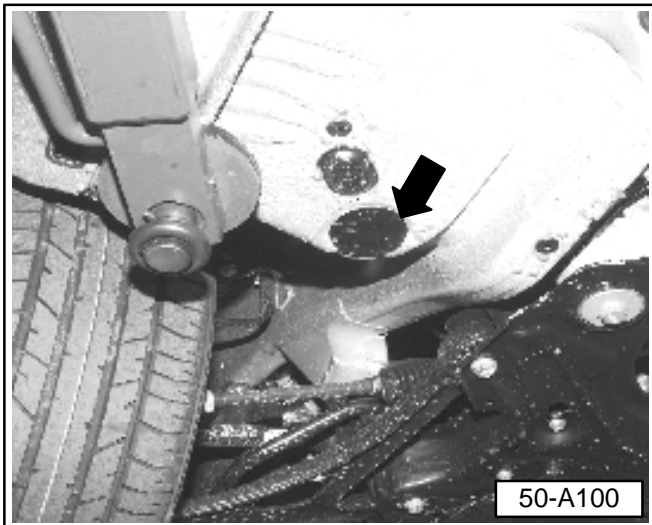
Sill panel undercoating or body damage due to contact with hoist lift arms or floor jacks.

- Repair body damage or undercoating as necessary.
- Remove round body plugs -arrow- from both left and right sides of vehicle at front of vehicle.
- Install hoist lift point pads into these locations (pads must be fully seated, see installation instructions on page 2).
