**Subject: Malfunction Indicator Lamp (MIL) ON, DTC P0411
(16795) Stored in DTC Memory**

Number: 00-06

**Model(s): TT with 1.8L Turbo
(eng, codes ATC, AMU)**

Date: Dec. 20, 2000

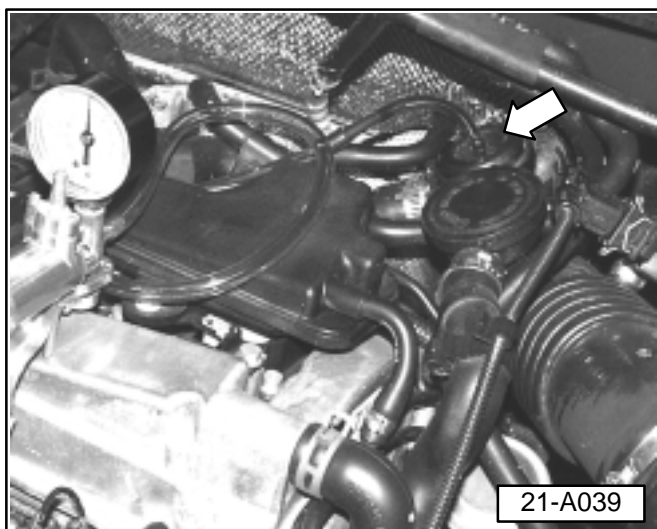
May be caused by a faulty Charge pressure bypass valve, since both the Charge pressure bypass valve and the Combi-valve for Secondary air system share a common vacuum source.

If Charge pressure bypass valve does not hold vacuum, there will not be enough vacuum during Secondary Air diagnosis to open the Combi-valve and the system stores DTC P0411 (16795) "Secondary air system incorrect Flow Detected" in DTC memory.

- Remove upper engine cover.
- ◀ - Disconnect vacuum line at bypass valve (arrow).
- Connect V.A.G. 1390 hand vacuum pump (or equivalent) to bypass valve.
- Operate vacuum pump to achieve at least 15in. Hg (vacuum).
- ◆ System should hold at least 15in. Hg (vacuum).

- Replace Charge pressure bypass valve.
- Clear any stored DTC's.
- Install upper engine cover.
